Committed to Responsible Tailings Management

AGNICO EAGLE

2025
Tailings Summary Report

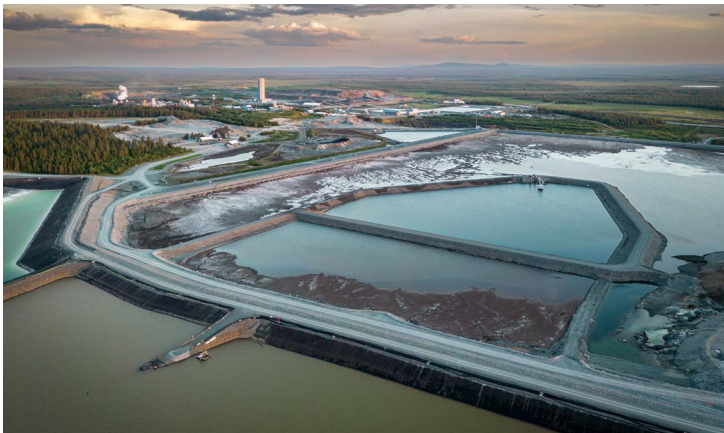
General view of Kittilä CIL2 – Slurry Tailings Facility.

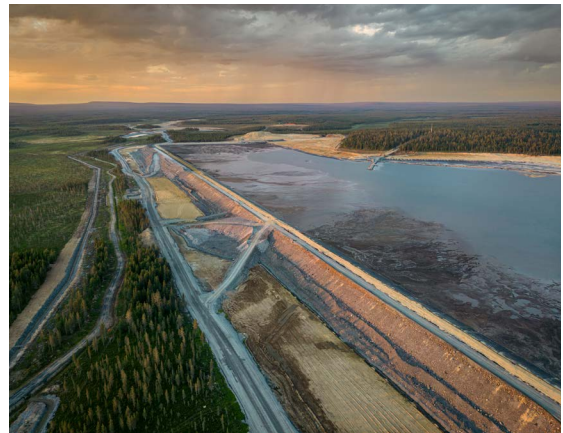
NP4 TSF at Kittilä Mine under construction.

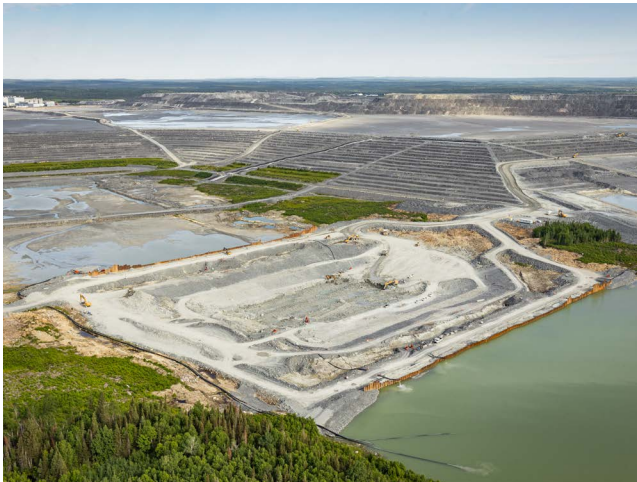
Shear Key construction at dike PR7, in 2023, at Canadian Malartic.

- Note 30:** PR7 – A 60m wide stability shear key was built between February and July 2022 by excavation of the clay and replacement with rockfill to reduce the risks associated with clayey foundations.

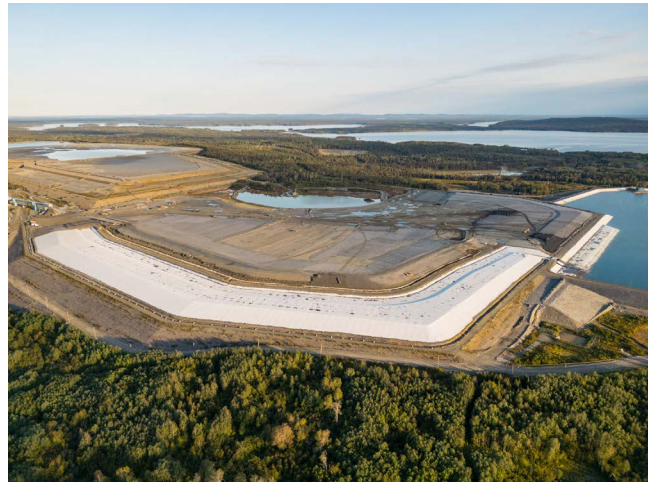
Filtered Tailings Stack constructed on a former Slurry Tailings deposition cell at Laronde, September 2024.

- LaRonde, transitioned from slurry to filtered tailings technology in 2022. LaRonde transitioned from slurry to filtered tailings technology in 2022. The transition followed an alternative assessment process and trade off study. The decision to construct the filtered stack above an existing slurry TSF allows optimizing already impacted areas, to remove the water pond, to reduce the uncertainties regarding closure costs, to incorporate the possibility of using filtered tailings as a construction material for the closure of other existing tailings and deposition areas.

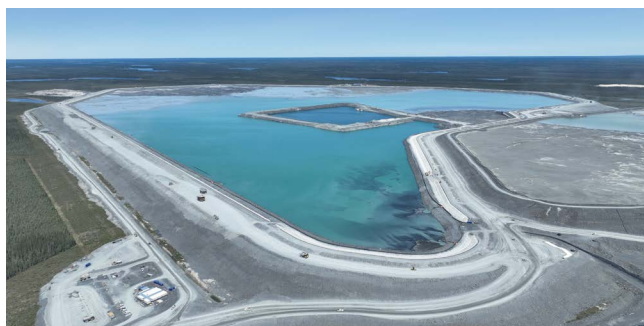
Detour Lake Cell 2 TSF – Slurry Tailings Facility.

Some of Agnico Eagle's tailings deposits are discharged as slurry tailings (i.e., Detour Lake Cell 2 TSF), which can release significant excess water after placement; or as thickened tailings (i.e., Canadian Malartic TSF), which release only minor amounts of excess water after the placement; or as filtered tailings (Meliadine TSF, Pinos Altos TSFs and LaRonde A4 Extension TSF), which release minimal water after placement.

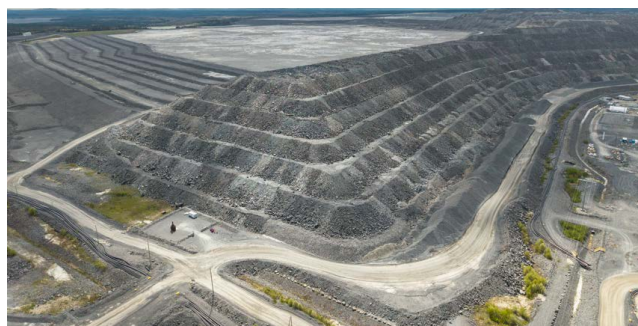
Thickened Tailings Facility at Canadian Malartic.

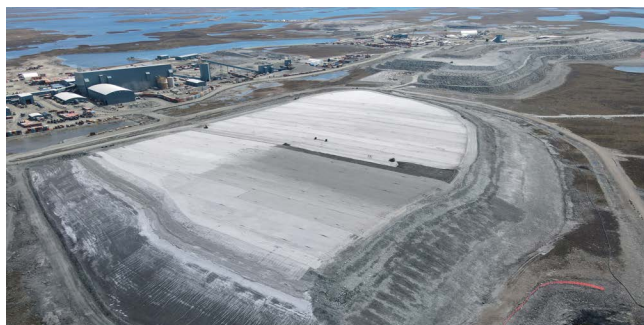
Filtered Tailings Stack at Meliadine.

- The Meliadine Filtered Stack is engineered for permafrost conditions, with a design that incorporates climate change considerations and encourages freeze-back.

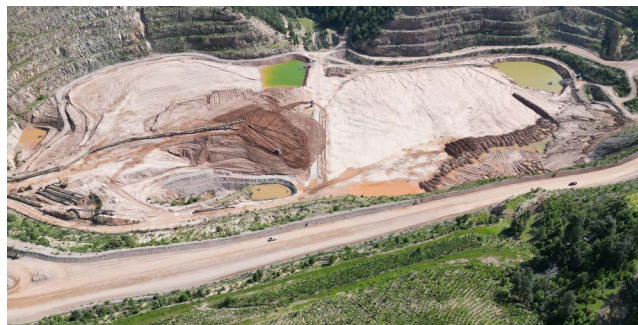
In-Pit Filtered Tailings Stack at Pinos Altos.

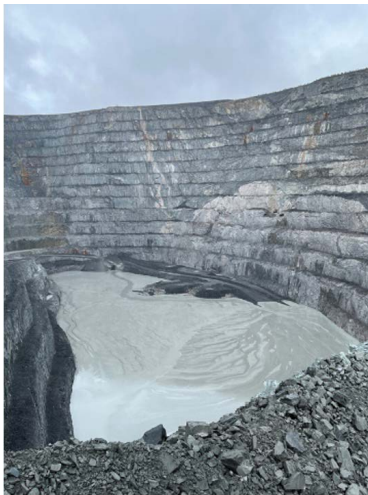
In-Pit Thickened Tailings Deposition at Canadian Malartic Mine.

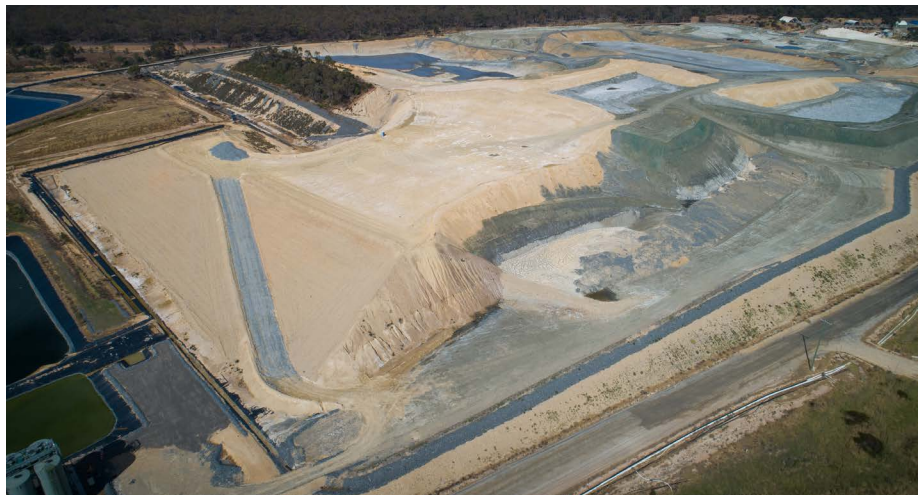
Tailings Storage Facility for one of the two streams of tailings at Fosterville.

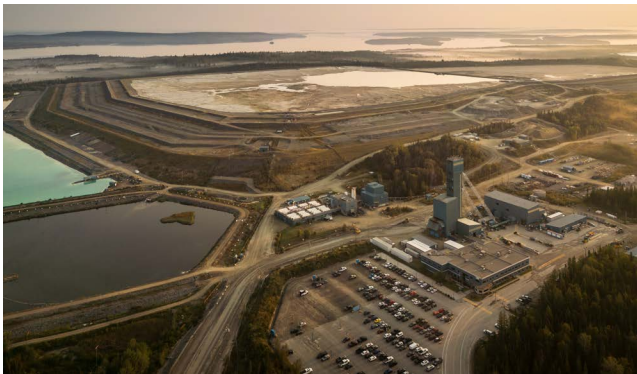
Main TSF at LaRonde – Slurry Tailings Facility.

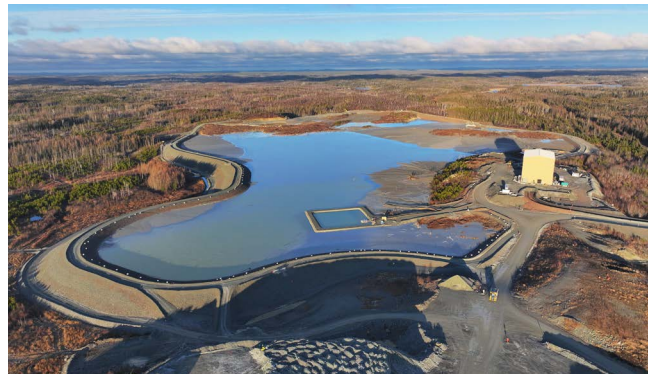
NTSF Slurry Tailings Facility at Macassa Mine.
